## ASSESSMENT OF TECHNICAL STATE OF UNFINISHED STRUCTURES OF THE DNISTROVSKA PSP

The paper considers the results of the research of civil structures reliability and safety of the Dnistrovska PSP hydraulic structures (HS).

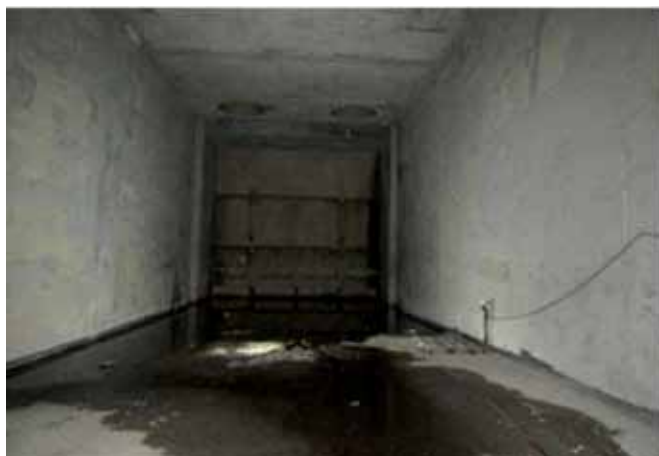
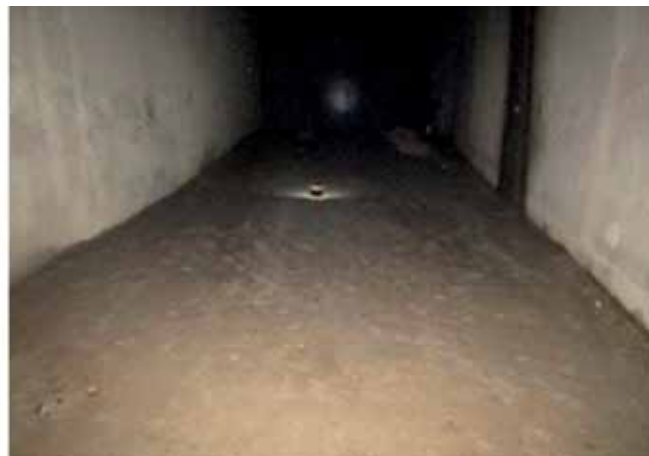
**Figure 5** – The general view of water intake 7 and water outlet 6

The flow-through parts of water intakes and water outlets. During the visual inspection of the fixtures of the flow-through parts of water intakes and water outlets of hydroelectric units 5-7, the following defects and damages were recorded: soaking in the areas of walls, ceiling and bottom; cracks with opening width from 0.1 mm to 0.4 mm in the walls areas; bared and corrod-ed reinforcement; poor concreting; efflorescences on walls areas, ceilings and bottoms due to filtration of water through concrete in some areas of the water intake flow-through part are not removed.

According to paragraph 5.2 of DSTU-N B V.1.2-18: 2016 [4], the results of the fixture inspection of the flow-through parts of water intakes and water outlets of hydroelectric units 5-7 allow to characterize the technical condition of the fixture reinforced concrete as satisfactory.

Based on the visual inspection of flow-through parts of water intakes and water outlets of hydroelectric units 5-7 the following is recommended: to inject the zones of concrete contact with soil mass in order to reduce filtration; to perform cracks cleaning and injection of appropriate solutions in the area of cracks in the concrete of the flowing part fixture of the water intakes; to eliminate protrusions, sags

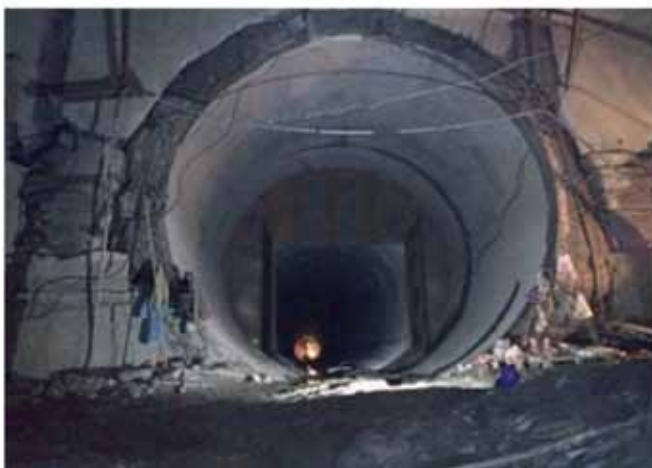
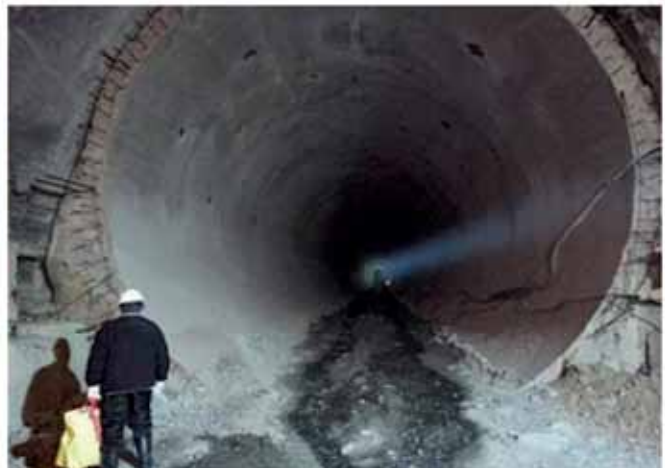
**Figure 6** – Conduits 5 and 6: a – cross section; б – conduit reinforcement; в, г – gen-eral views on ПК1+96.4 and on ПК1+85.04 from access adit 1 of conduit 5 and conduit 6, respectively

During the full-scale inspection of water conduits 5 and 6 several defects and damages of the reinforced concrete fixture were revealed. They were included in the following groups:

- a map cracking on a fixture surface;
- poor quality of concreting the local areas of walls with sinks, cracks and formwork shear traces on the surface;

- fixture surface unevenness and concrete sags around the concreting joints;
- cracks at the concreting joints;
- cracks in concrete sags near concreting joints;

- individual cracks up to 1.0 mm in the walls;
- concrete sags on the tunnel walls;
- concrete massifs in the flume part of the tunnel;
- the presence of soil, rock fragments and construction debris in the flume part;

- point seeping through the walls and vaults of the tunnel, some with water dripping;
- walls soaking with local strips from 0.2 to 2 m wide;
- separate soaking of walls with traces of rust;

Taking into account the results of the field survey, as well as the results of instrumental and laboratory tests, the technical condition of reinforced concrete fixture of water conduits 5 and 6 within the surveyed areas was assessed as satisfactory according to paragraph 5.2 DSTU-N B V.1.2-18: 2016 [ 4].
