EXPERIMENTAL MONITORING AND DYNAMIC CERTIFICATION OF BUILDING STRUCTURES

We would like to consider how up-to-date regulatory requirements are used for scientific and technical support and monitoring of structures [6-11] for safe arrangement of the pile foundation on a landslide prone construction site in conditions of dense urban development at the address 14, Pimonenka street, Kyiv in case of installation of

a bored pile № 87 with a diameter of 820 mm in accordance with the plan of pile field. The working area with a well for the bored pile is at a distance of 18-20 m from the nine-storeyed residential brick building. The area of the construction site is below the level of the area of the adjacent building and there is a retaining wall made of concrete blocks being 5 m high on the boundary. The mutual

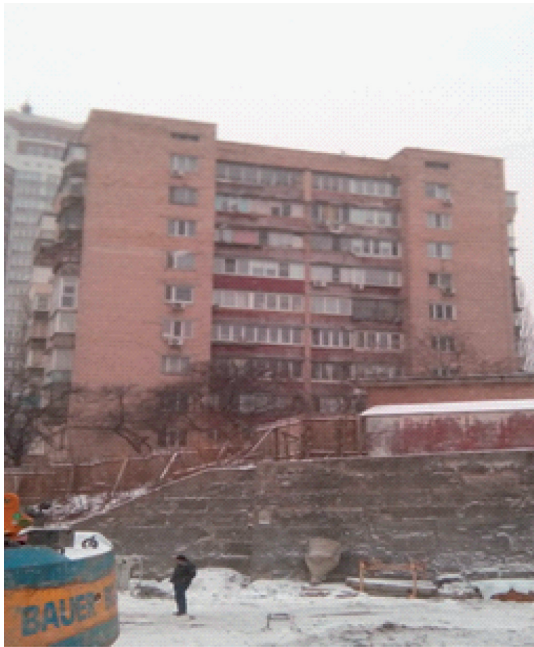
location of the building, the retaining wall and the construction site is presented in Fig. 1

Figure 1 - Investigated building and retaining wall - View

According to the present DBNs [26-31] the inspection of technical condition of the structures of the nine-storeyed building was performed in advance prior to drilling works, see (Fig. 1).

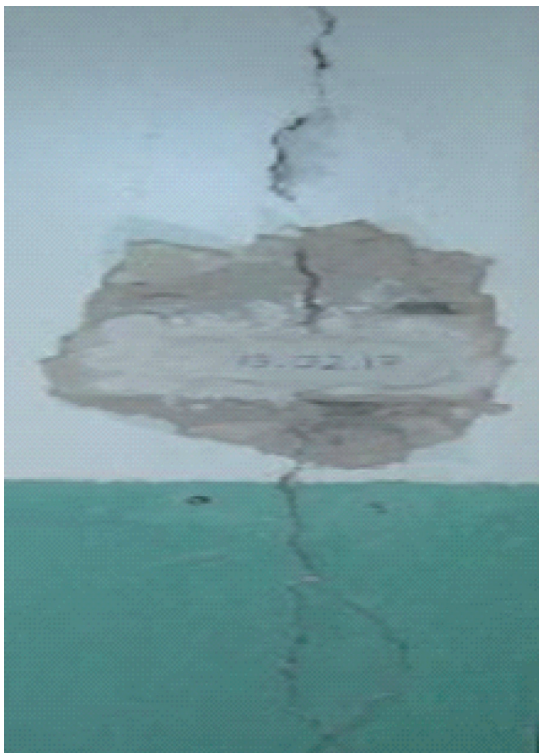
Figure 2 - Chalky screed after the installation of the pile

During the study of the technical condition of the structures, visible damage in the places available for this site and their possible development was assessed before the beginning of the works and during and after the installation of piles. The monitoring of the impact on building caused by drilling was monitored not only instrumentally, but also visually, by periodic observations during the arrangement of the bored pile № 87 with a diameter of 820 mm and with regard to the integrity of the chalky screed in a vertical crack in the bearing brick wall of the house at the 8th floor. The screed was installed in advance before the beginning of drilling (see Fig. 2).

3. In the research, the presence of visible damages to the building in the available places and possible development before and after pile installation was also assessed. Their development was evaluated according to a plaster screed on a vertical crack in the wall of the building. The state of the chalky screed on the vertical crack at the 8th floor was identified before the beginning of vibration dynamic tests on 02/15/2017. At the moment of the research on 02/21/2017 and after the installation of a concrete pile and next arrangement of pile foundation the state of the chalky screed has not changed. It remained undamaged. This is shown in the photo (Fig. 2).

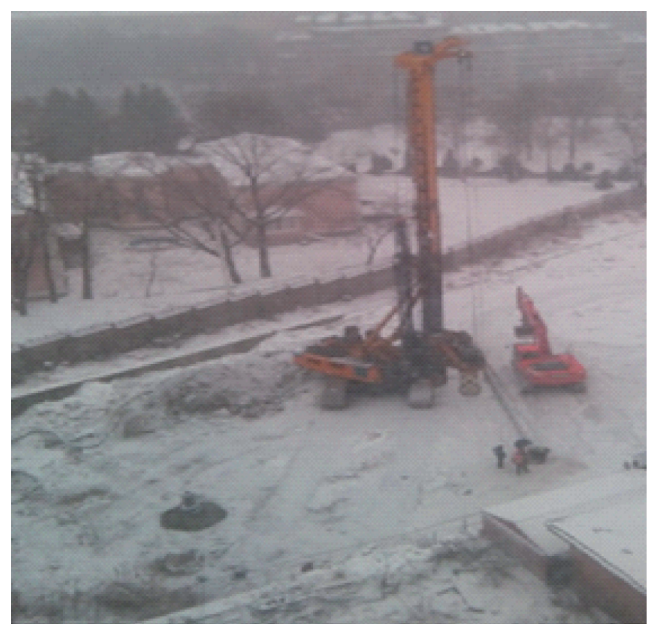
Figure 4 - Construction site located near the building at 14, Pimonenko street (view from the flat on the 9th floor)

Well drilling was performed by the BAUER 40 BG rotary drilling rig (Fig. 3). In the photo (Fig. 4) there is a view of the building investigated and the retaining wall alongside of the construction site. During the research period, one BAUER 40 BG rotary drilling rig (Fig. 3) worked on the site.

4. Based on the above mentioned, it is necessary to carry out arrangement of pile foundation in accordance with the relevant technological procedures during the operation of the BAUER 40 BG rotary drilling rig (see Fig. 3-4).

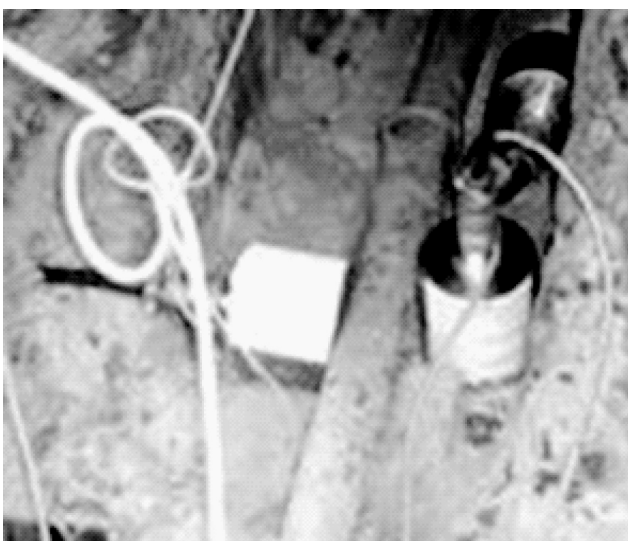
The vibration sensors were located on the foundation of the building (there were 3 vibration sensors) and oriented towards X, Z and Y directions (Fig. 5); two vibration sensors were located on the floor of the 9th floor of the building and were oriented towards X, Z or Y, Z directions (Fig. 6). The change in the orientation of the vibration sensors for the measurement of vibration acceleration was conducted in concert with the moment of their registration.

Figure 5 - Vibration sensors № 1, № 2 and № 3 for the registration of foundation oscillations oriented towards X, Z and Y directions

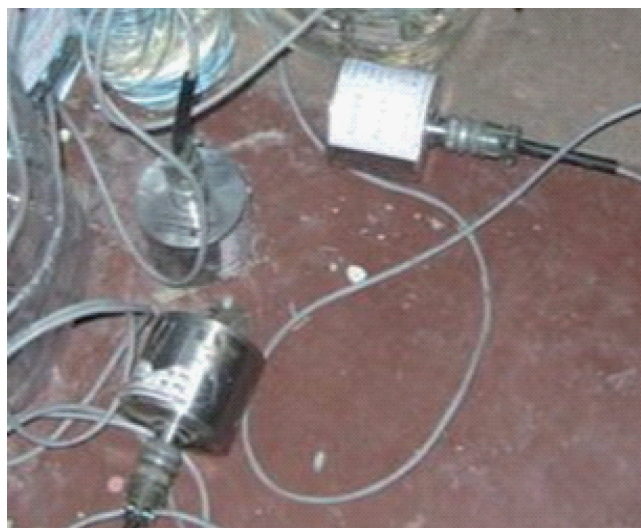
Figure 6 - Vibration sensors № 4 and № 5 for the registration of oscillations of the 9th floor of the building oriented towards X, Z or Y, Z directions
