THE PROBLEMS OF CHEMICAL CORROSION OF CONCRETE ON RAILWAYS OF UKRAINE

The types of defects arising in the concrete sleepers on the railway tracks of Ukraine are investigated. It is established that the causes of cracks can be both permanent dynamic loads and the destruction of concrete due to alkali corrosion. The most common cases are the combined action of loads (occurrence of force cracks), corrosion (development of cracks) and freezing of water under the action of low temperatures. It is known that gel is generated during the chemical interaction between the various forms of silicic acid, which is differently contained in the fillers of different types, solutions of alkali metal hydroxides, which fill the pores of the matured concrete and alkali penetrating from the outside. Such a newly formed structure is able to absorb water and increase in volume, and thus leads to the formation of microcracks in the concrete and, eventually, the destruction of the concrete. Chemical microscopic examinations of aggregates and cement were carried out for the concrete aimed for sleepers. Studies showed that cements of Ukrainian production had an excessive content of alkaline component. Based

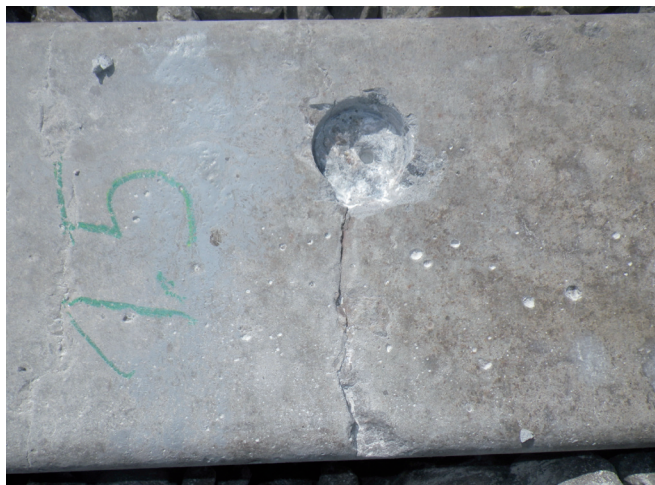
Looking at the photo of a sleeper produced in 2017 (Figure 5), it can be noted that there are transverse cracks of the sleeper concrete which occur in high power load. This means that the significant cracks in sleepers, which could be attributed to the cracks resulting from alkaline corrosion are not found. The amount of gel is already insufficient for the destruction of concrete in its pure form as a result of alkaline corrosion, but still enough to initiate force cracks due to corrosion of concrete. This in turn leads to the formation of a comprehensive effect of various harmful factors on the concrete which destroy sleepers.

Figure 5 – Cracks within concrete sleeper

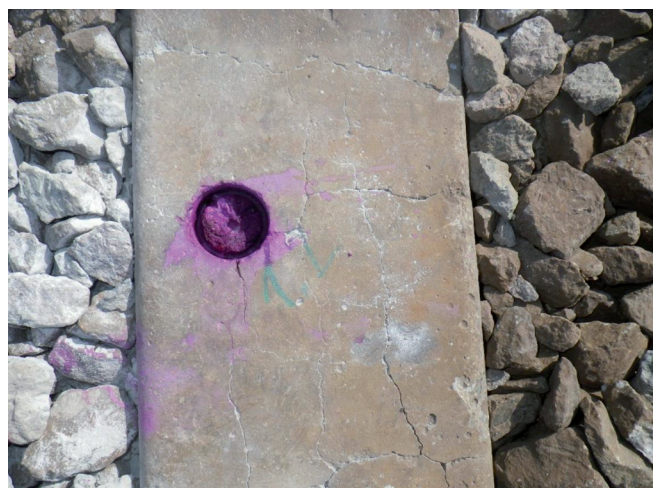
Analyzing the microstructure of the cement stone given on Figure 6, one can observe that the number and size of granules of alkaline-silicate gel has increased in comparison to the the amount of gel in the sleepers produced in 2017. The microstructure of cement stone given in Figure 7 is presented by hydrated cement and provides microcracks which are expected to ruin the concrete. The size of the gel granules have increased even more. The amount of alkaline-silicate gel is enough to bring to the deterioration of concrete attributed to alkaline corrosion (Fig. 8).

Figure 8 – Cracking on the sleeper produced in 2010

type, M500, normalized composition exceeds the allowable value of 0.6% [12] according to the data of Association of Ukrainian Cement in 2019 and this is the reason why it is necessary to introduce mineral admixtures in concrete and to fix alkali into insoluble form as it is recommended in [5,11]. These admixtures can be aluminosilicate substances, for example slag, ash. This technological solution is confirmed by the content of paragraph 5.11 [12].

Slag admixture can be introduced in cement making and this will simplify the technology of concrete, this means the application of cement of grade PC II / A-W with a content of granular slag up to 20% while maintaining the quality of concrete according to [13]. Such a positive solution will not only reduce the alkaline corrosion of concrete due to the interaction of cement slag with alkali and the formation of insoluble [1] but also contribute to lowering of prime costs.
