## ASSESSMENT OF TECHNICAL STATE OF UNFINISHED STRUCTURES OF THE DNISTROVSKA PSP

The paper considers the results of the research of civil structures reliability and safety of the Dnistrovska PSP hydraulic structures (HS).

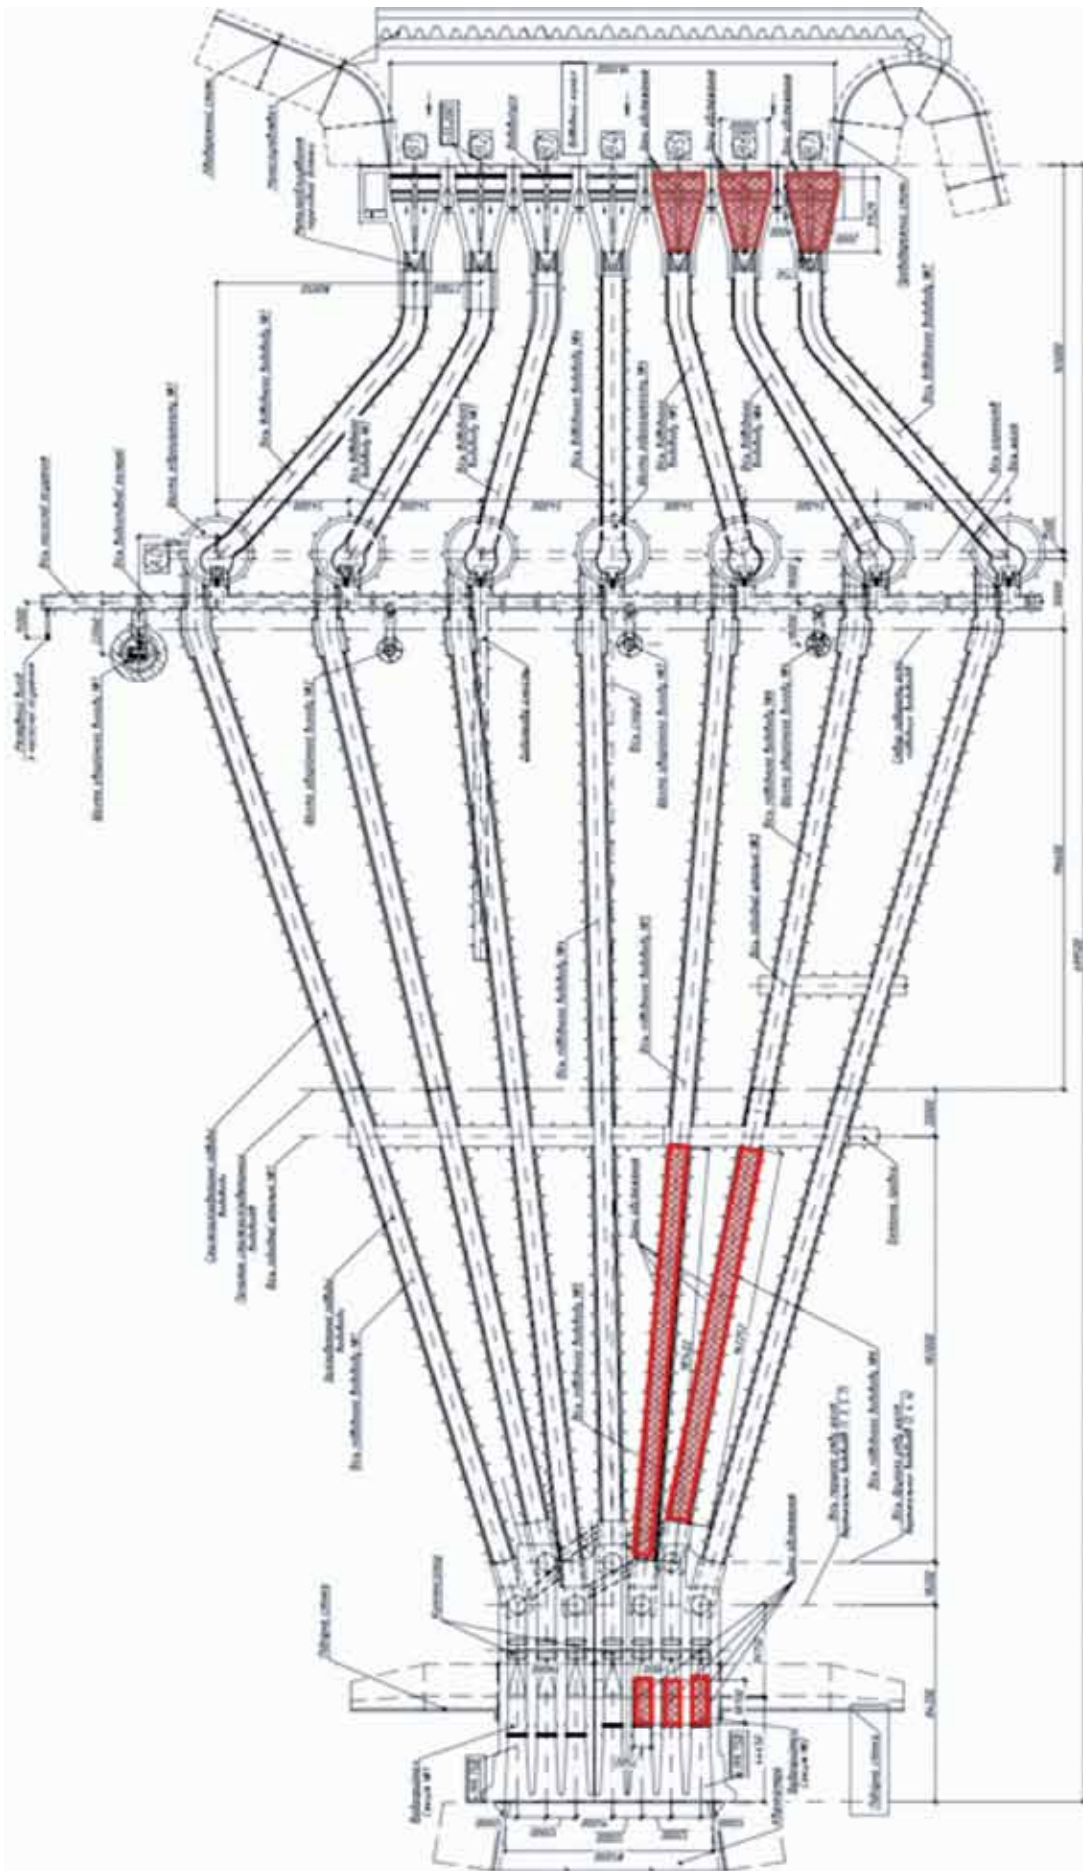
**Figure 3** – The plan of the flow-through system at the Dnistrovska PSP  
Note: The red color shows the flow-through elements, the technical condition of which is surveyed by the NIISK experts

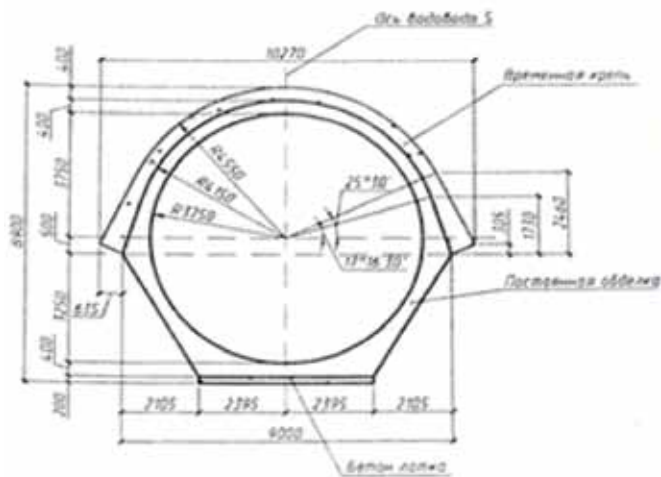
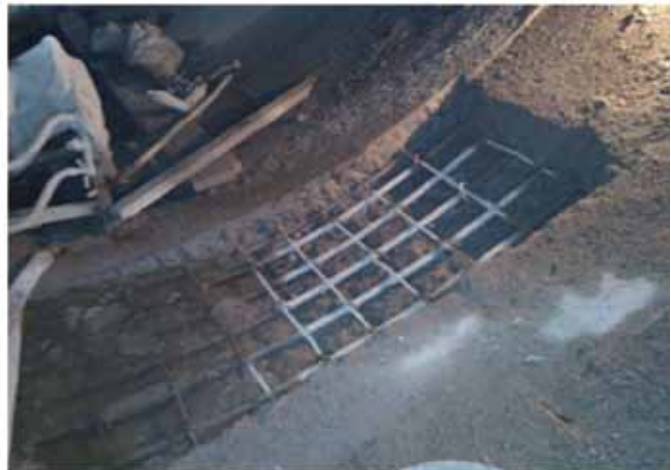
**Figure 6** – Conduits 5 and 6: a – cross section; б – conduit reinforcement; в, г – gen-eral views on ПК1+96.4 and on ПК1+85.04 from access adit 1 of conduit 5 and conduit 6, respectively

At the survey time in December 2020, all these areas of water conduits 5 and 6 were mainly completed (Fig. 6). The transition area with a length of about 12 m, which should be arranged at the intersection of water conduits and access adit 1, remained unfulfilled.
